[별 첨1] 측정 위치도(측정 장소)

군산시 구암동 공동주택 개발계획 신축공사 석면해체 제거	측정일시	22.04.28
--------------------------------	------	----------

[별첨2] 측정 결과

[별첨3] 측정 사진. (측정일시 : 2022.04.28)

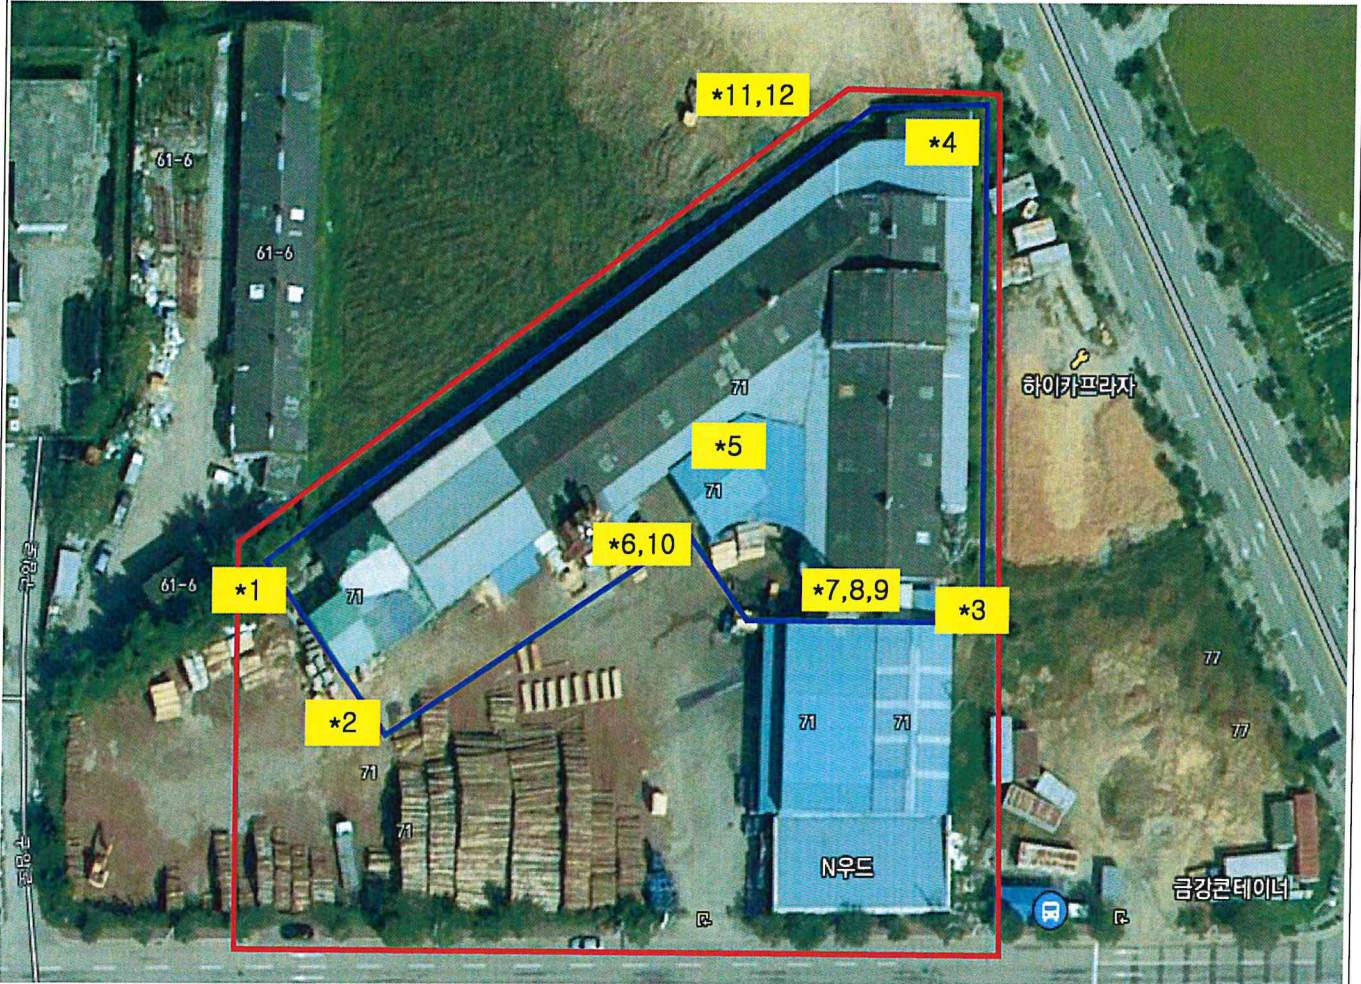
[별첨1] 측정 위치도(측정 장소)

군산시 구암동 공동주택 개발계획 신축공사 석면해체 제거	측정일시	22.04.30
--------------------------------	------	----------

범례	*NO

시료채취	부지경계선	대상건축물

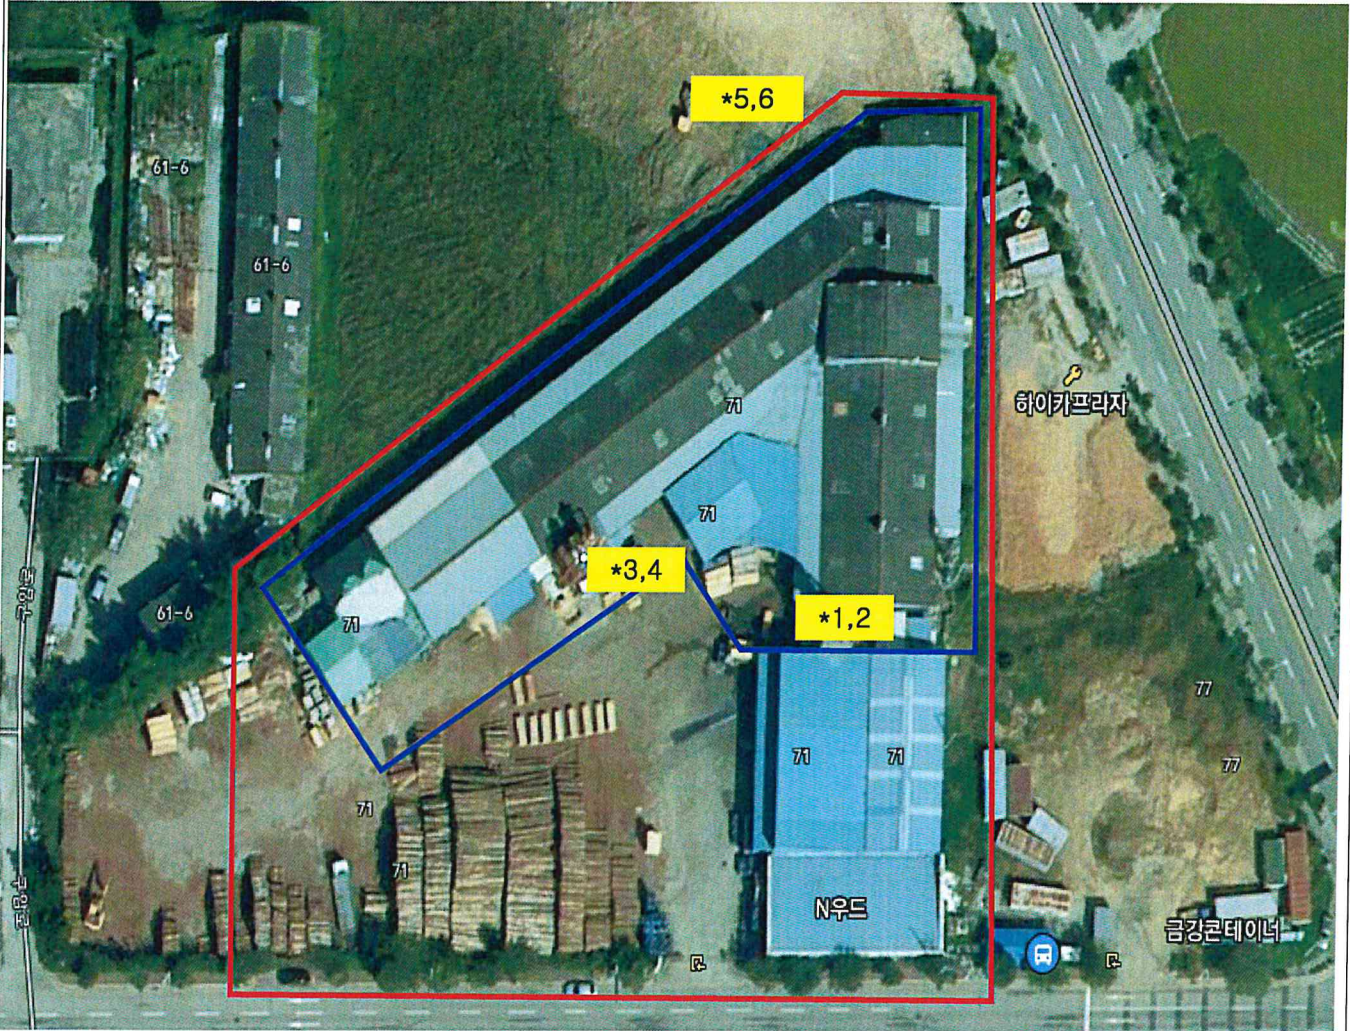
[별첨1] 측정 위치도(측정 장소)

군산시 구암동 공동주택 개발계획 신축공사 석면해체 제거	측정일시	22.05.01
--------------------------------	------	----------

범례	*NO

시료채취	부지경계선	대상건축물
